GROOPS DAM

PHASE I INSPECTION REPORT NATIONAL DAM INSPECTION PROGRAM

CROOPS DAM, NDS I.D. No. PA 01063

PHASE I INSPECTION REPORT
NATIONAL DAM INSPECTION PROGRAM
CROOPS DAM
NATIONAL ID NO. PA 01063
DER NO. 40-227

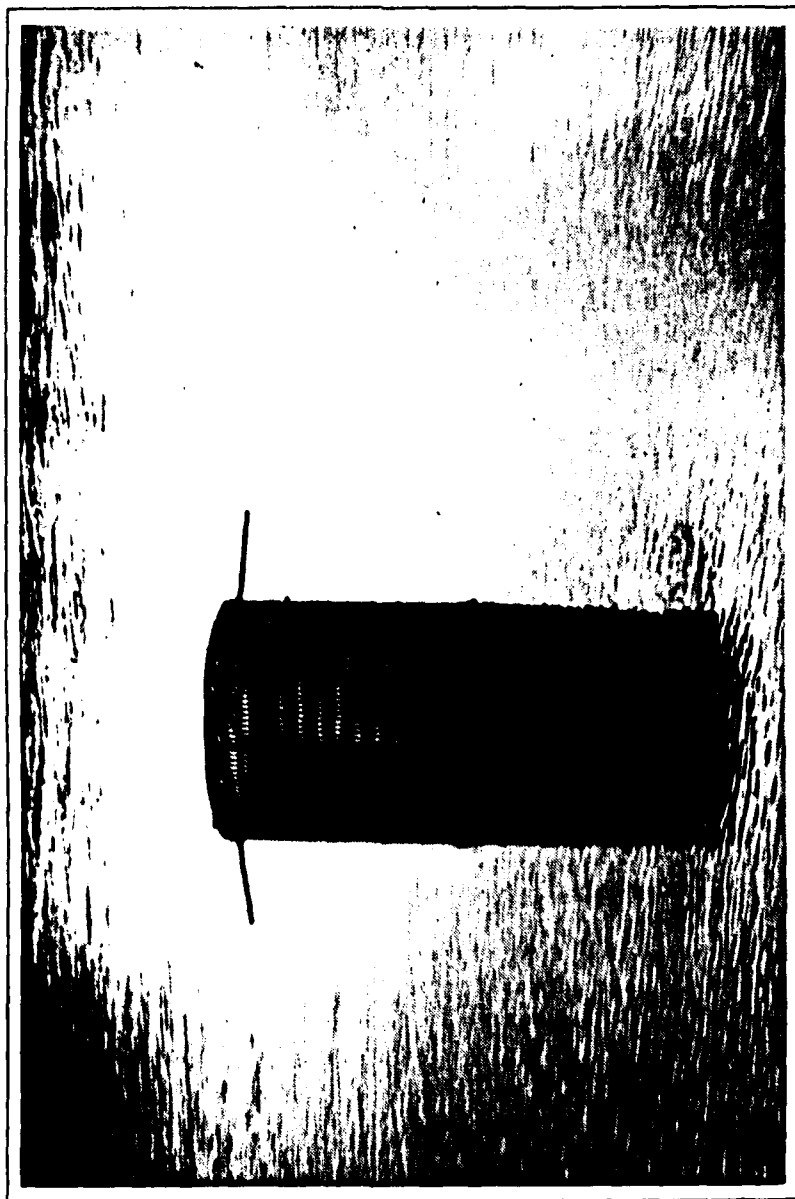
PHOTOGRAPH NO. 1

Reservoir side slopes are moderate to steep and vegetated to water's edge with trees or grass. No large debris was noted, but small branches and leaves were noted which could block the screen over the riser or overflow pipes.

SPILLWAY INTAKE SCREEN.

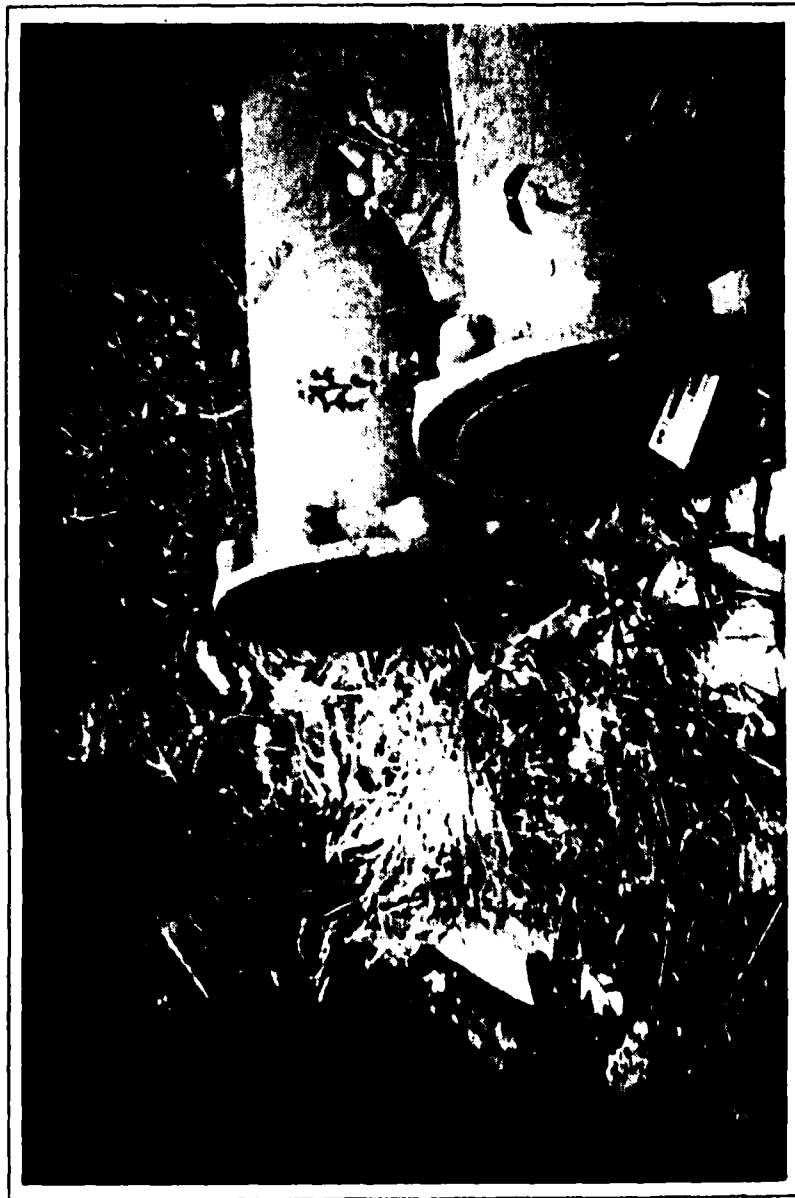
PHOTOGRAPH NO. 3

The overflow spillway consists of two 12 inch diameter cast iron pipes through the embankment approximately three feet below the crest (Photograph 3). The upstream invert of these pipes is at about elevation 754.8, and the pipes discharge directly on the downstream face of the dam.

EMERGENCY SPILLWAY PIPES-INTAKE
AT UPSTREAM CREST.
